Using Bonding Enamel-Coated Steel Fixtures to Produce More Durable Brick/Masonry Structures

Principal Investigator:	Steven C. Sweeney	CERL
Co-Investigators:	Brett A. Williams	GSL
	Charles A. Weiss, Jr.	GSL
	Sean W. Morefield	CERL
	Philip G. Malone	GSL

F10AR12 – Use of Corrosion-Resistant Bonding Enamel-Coated Steel Fixtures in Masonry Wall Construction

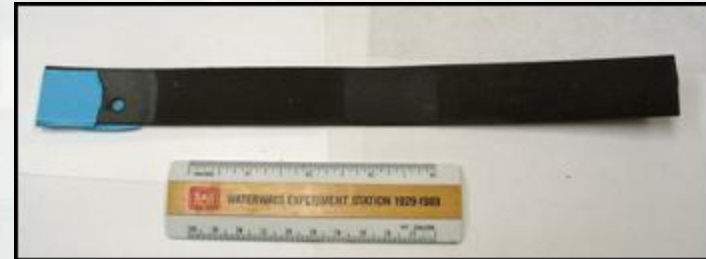
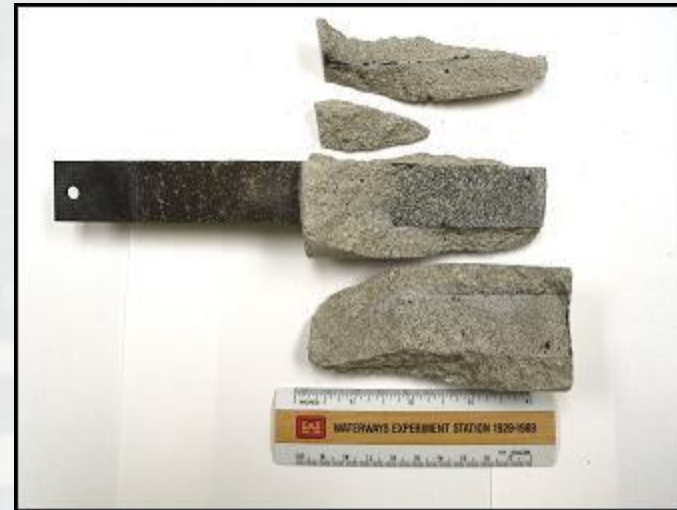
Bonding Enamel Increases Peak Pull-out Stress

- Enamel on a strap can increase the adhesion of the surface of the metal to the surrounding mortar
- Initial tests with enameled metal straps cracked all the test cylinders and straps would not pull out

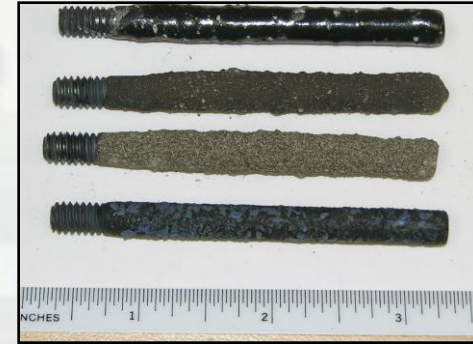
Cement fused to the glass enamel makes strong bond to surrounding mortar

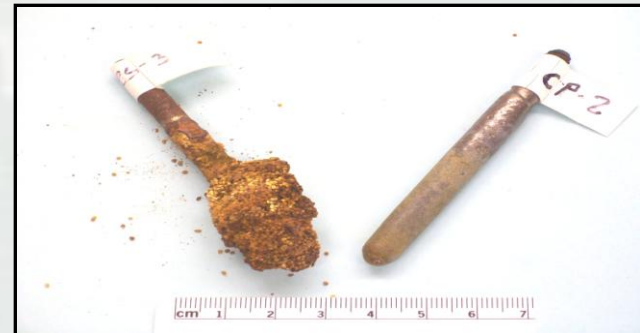
Steel is protected from corrosion as long as glass enamel is intact

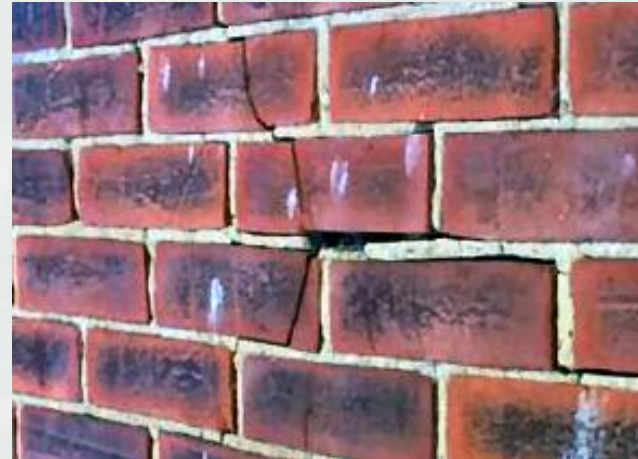
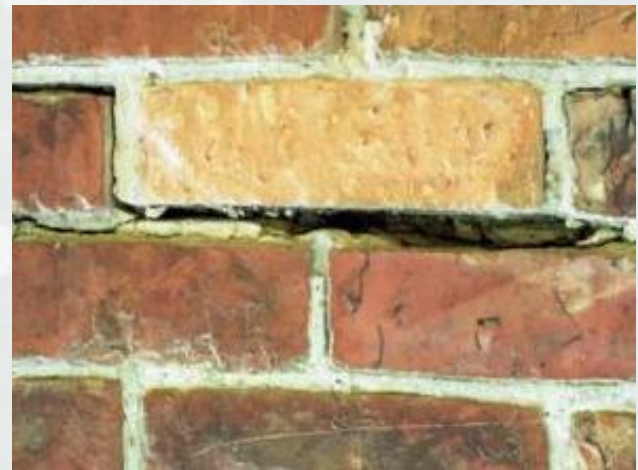
Corrosion of Ties Breaks Bricks and Mortar

- Corrosion increases the volume of the iron that reacts by 600% and cracks the mortar
- Porosity of bricks hold moisture for long periods of times
- The thick layer of concrete (mortar) that would offer protection to steel reinforcement is not present

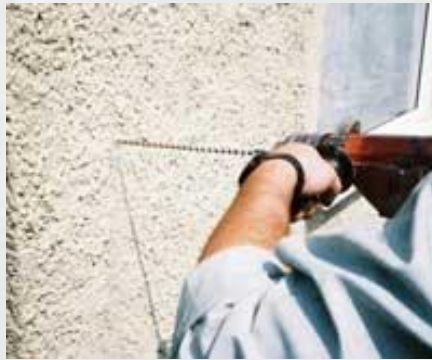
Drill View Port

Ports can be installed as the wall is assembled

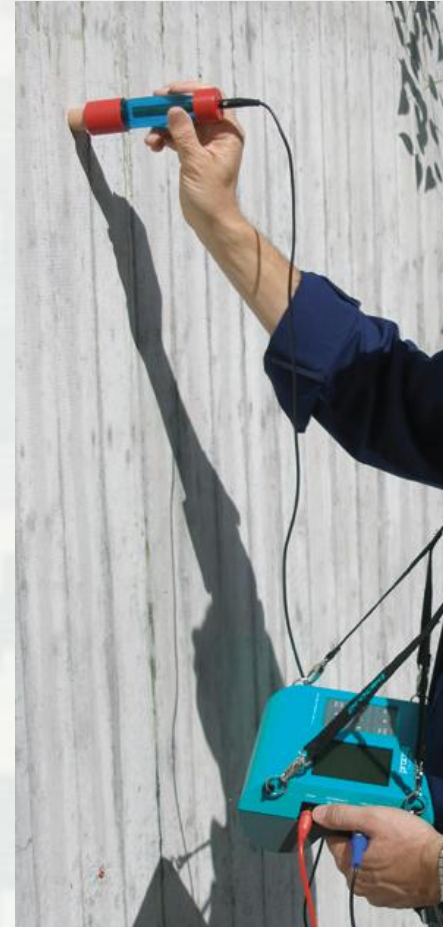
Electrical Corrosion Monitoring

- Half-cell corrosion potential method - accurate field potential measurements aid in detecting active corrosion
- Electrical corrosion monitor leads installed during construction
